Waterproofing System for Wastewater Tanks in Petrochemical Industries and Refineries

Case History

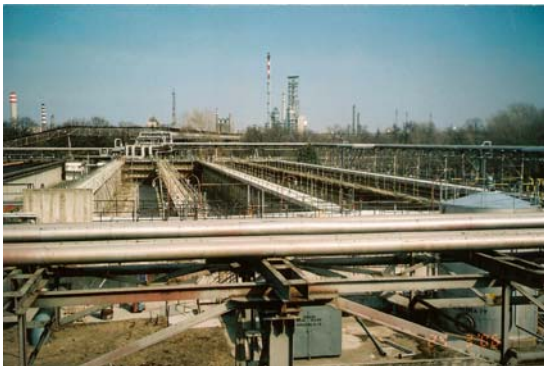
Figure 1. The first tank during the repair

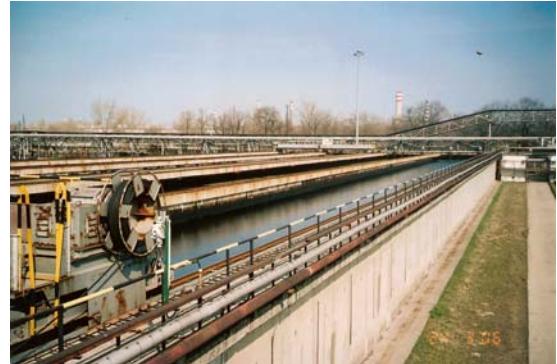
Figure 2. The second tank before the repair

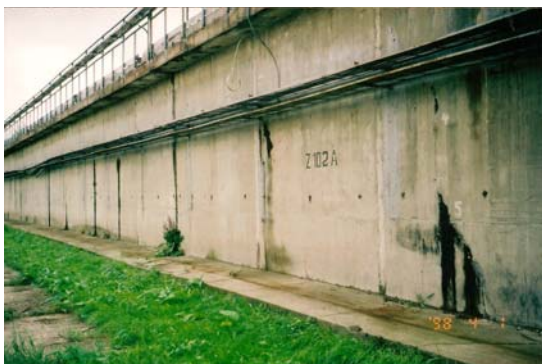
The reinforced concrete tanks have developed leaks mainly through cracks, construction joints and expansion joints. There were also leaks in areas of poor concrete compaction and in the section where the mechanical equipment was anchored in the concrete. The leaks, shown in Figure 3 present a serious ecological problem. In addition to cracks, the “low” concrete cover on steel resulted in corrosion of reinforcing steel, causing cracking, delamination and spalling of concrete as shown in Figure 4.

Figure 3. Leaks in concrete tanks

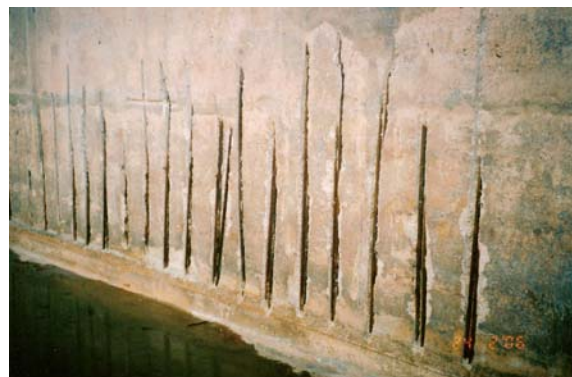
Figure 4. Delaminating concrete due to corrosion of reinforcing steel

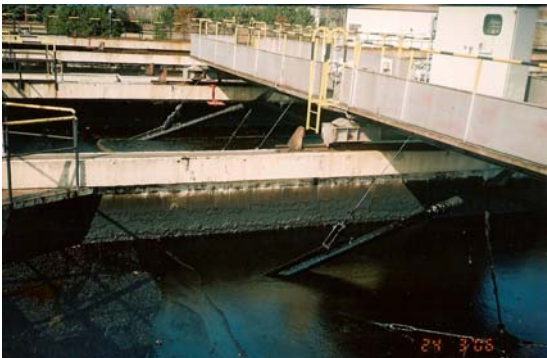
The key challenge presented in the repair and waterproofing of the reinforced concrete tanks has been “in depth” oil contamination of reinforced concrete tanks. The interior surface of concrete tanks was covered with approximately 12 – 18 mm (½- ¾ in) thick layer of black oily residues, shown in Figure 5., which prevent bonding of virtually any material. Figure 6. shows the tanks after chemical cleaning. The further challenge was to span the existing moving cracks. The cracks and expansion joints move due to temperature changes and, to some extent, by the varying hydrostatic head in reinforced concrete tanks.

Figure 5. Oil and grease deposits on the surface of concrete tanks

The layer of hydrocarbon deposits were first removed by mechanical scraping. This was followed by high-pressure water washing (approximately 3,500 psi–24 MPa) in combination with a heavy-duty industrial detergent. The cleaning procedure consisted of two steps. The detergent was first spray applied and left to act for approximately 30 minutes. This was followed by a thorough high-pressure hot water wash. The surface of concrete after chemical cleaning is shown in Figure 6. The final cleaning was done by sandblasting shown in Figure 7, and a high-pressure wash. In some areas, at the water level, several days after sandblasting and washing, the emulsified oil from within concrete was released to the surface by capillary pressures, shown in Figure 8. These areas were cleaned again using detergent and the high-pressure water wash. In such cases, it was important to apply the bonding agent immediately after cleaning, to develop bond before additional emulsified oil, see Figure 8, was released to the surface.

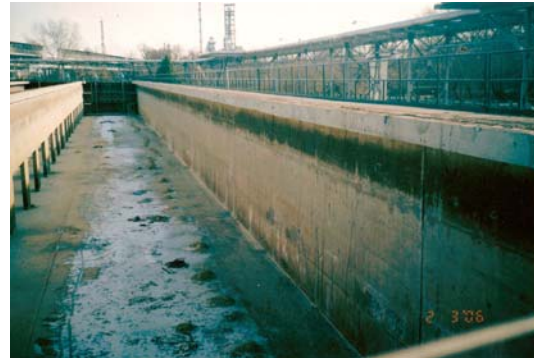
Figure 6: The surface of the tanks after chemical cleaning

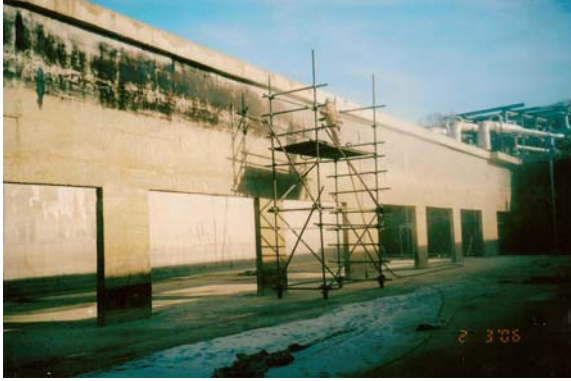
Figure 7. Sandblasting after chemical cleaning

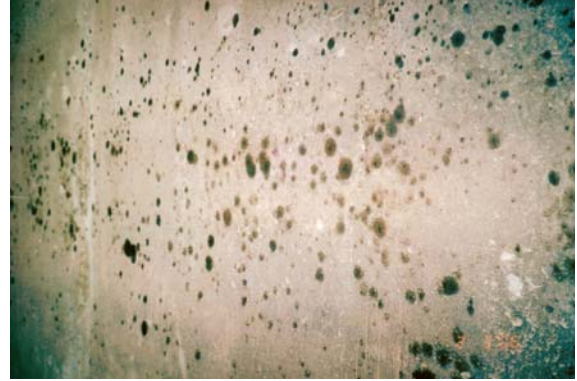
Figure 8. Residual emulsified oil “seeping out” of capillaries after sandblasting and high-pressure wash

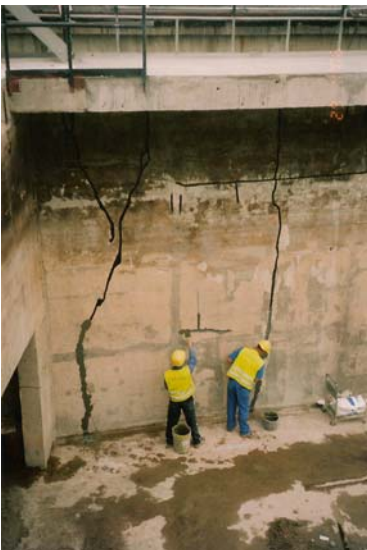
Figure 9. Filling the routed cracks with one component polyurethane

All cracks exposed by cleaning were cut and “routed out” with a chipping hammer to form a “groove”, approximately 2 cm ($\frac{3}{4}$ in) wide and 12 mm ($\frac{1}{2}$ in) deep. The crack was grind into depth of approximately 12 mm ($\frac{1}{2}$ in) and filled with one component polyurethane. The polyurethane was also applied to the entire area, including “cut” sides. After curing the polyurethane, the bonding agent was applied to polyurethane, and the grooves were filled with micro-silica enhanced, fiber reinforced mortar shown in Figure 9, 10 and 11. The surface the patch was again covered with a thin layer of one-component polyurethane. Delamination repairs varied in depth from 12 mm to 10 cm ($\frac{1}{2}$ to 4 in). The surface of exposed steel was protected by polymer cement based rust-proofing material. The same material was used as a bonding agent for the micro-silica enhanced, fibre reinforced mortar used in filling the delaminated areas, as shown in Figure 12.

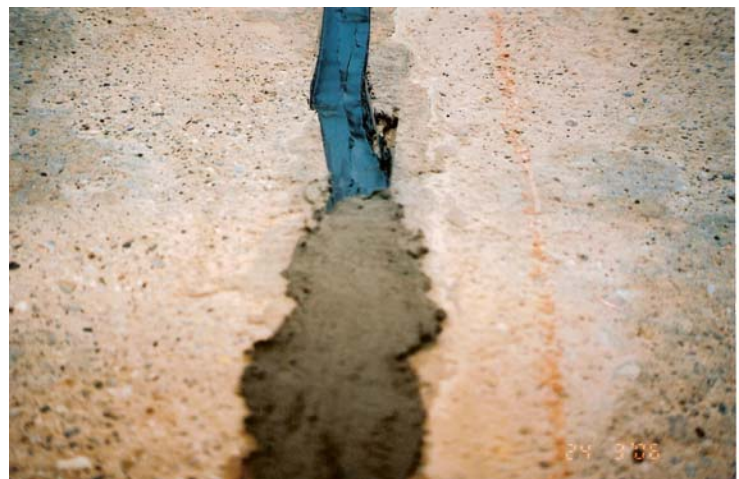
Figure 10. Cracks filled with fibre reinforced mortar bonded with bonding agent to the polyurethane seal

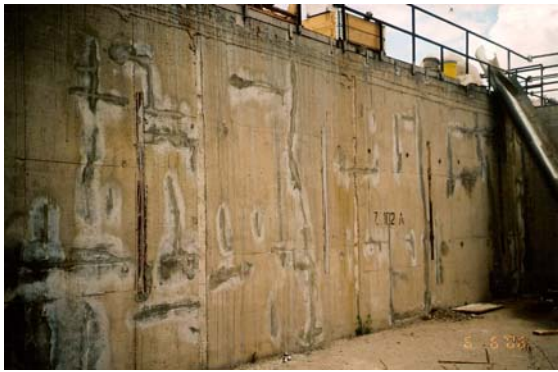
Figure 11. Cracks filled with fibre reinforced mortar bonded with polymer modified cement slurry to the polyurethane seal

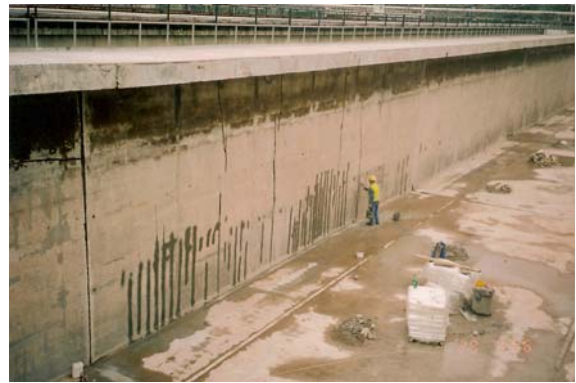
Figure 12. Delamination repairs using fibre reinforced mortar and polymer cement rust-proofing .

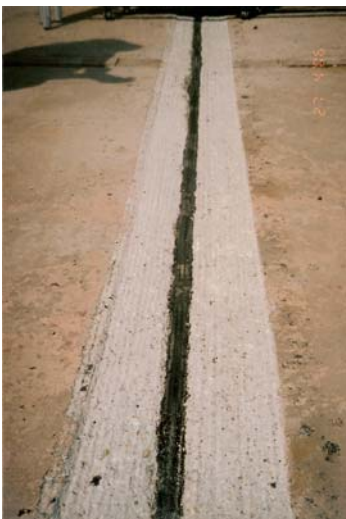
Figure 13: Expansion joint after milling, before placement of the sealant and the rubber sheet.

The original expansion joints were approximately 5 cm (2 in) wide, placed in 50 cm (20 in) thick slab. The original waterproofing was provided by a cast-in concrete water stop. This original treatment failed. Approximately 10 years ago, expansion joints were repaired using a flexible rubber tape, bonded to concrete. All these joint repairs failed again. The repair of the bottom slab joint started with milling off approximately 20 cm (8 in) wide and 12 mm (1/2 in) deep groove over the expansion joint as shown in Figure 13. The expansion joints were cleaned using wet sand-blast and repaired with fibre reinforced mortar, bonded with polymer modified cement slurry. This repair reduced the width of the joint to approximately 4 cm (1 3/4 in). The undamaged existing joint filling material was left in place, and the deteriorated joint filling material was replaced with extruded polystyrene. The 20 cm (8 in) wide area, including vertical sides was coated with one-component polyurethane. This was followed by placement of 2 mm thick layer of oil resistant rubber sheet embedded in to the joint. The joint was then covered with a sheet of stainless steel metal cover mechanically fastened to one side of the joint. The vertical joints were repaired using the same system, as shown in Figure 14.

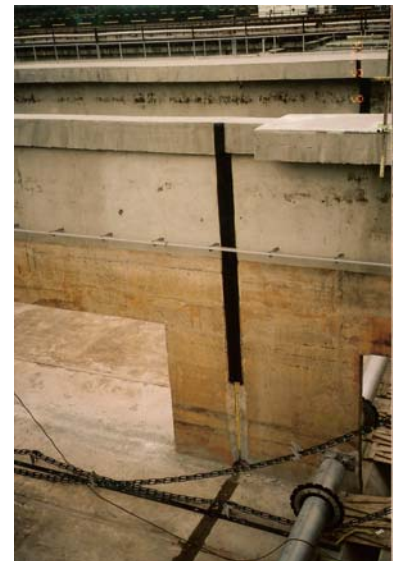
Figure 14. Repair of the vertical expansion joint.

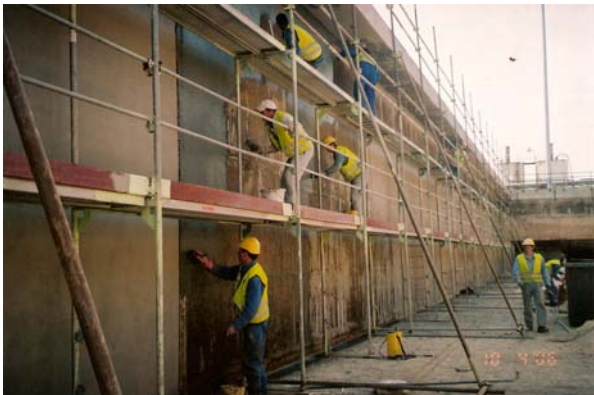
Figure 15. Application of the bonding agent and protective/waterproofing coating.

The polymer modified cement slurry was supplied as a two-component system, consisting of a bag of dry material and a liquid additive. These were thoroughly mixed using an electrical drill and a mortar-mixing paddle into a slurry form. The slurry was brush applied on the surface of concrete, including the polyurethane treated surface of crack repairs. The protective/waterproofing coating was supplied as one component material. It was mixed with water on site and applied by brushing (or spraying and brushing) into the wet bonding slurry of polymer modified cement slurry. The protective/waterproofing coating was applied in two coats to build a layer of total thickness of approximately 3 mm (1/8 in) and wet cured for three days. The application is shown in Figures 15 and 16.

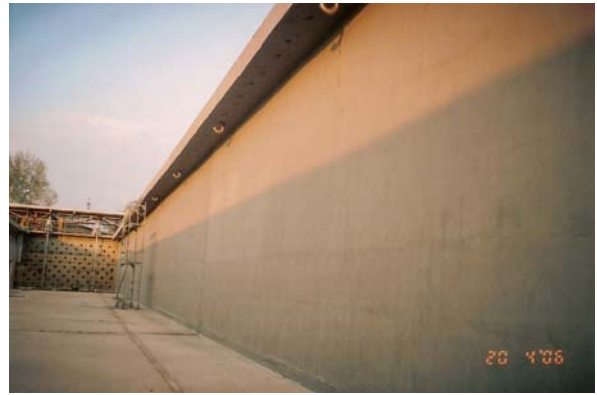
Figure 16. Finished interior of the tank

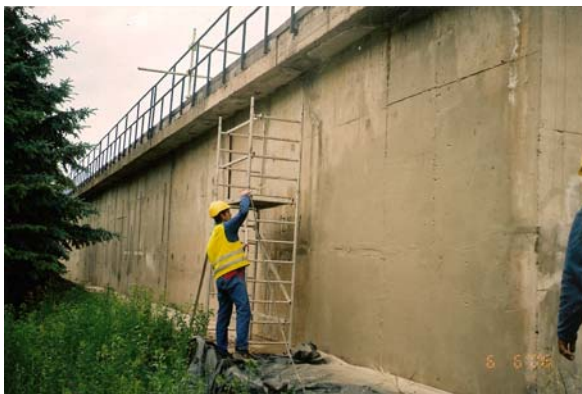
Figure 17. Application of one component polymer modified cement coating to the exterior of the tank

The exterior walls were protected with two coats of one component polymer modified cement coating, approximately 0.5 mm (20 mils) thick, mainly for aesthetic reasons. The coated exterior of the tank is shown in Figures 17 and 18.

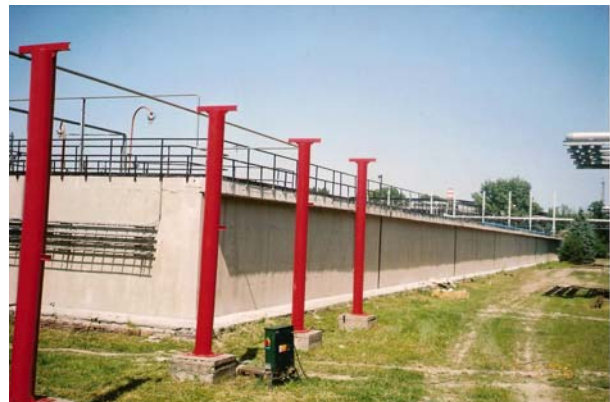
Figure 18. Exterior of the tank after the repair
