PROJECT PROFILE

Project: Dam repairs, **Korea**

Designer: KEPCO (Korean Energy and Power Corporation).

Gemite product: **Gem-Crete HDO**

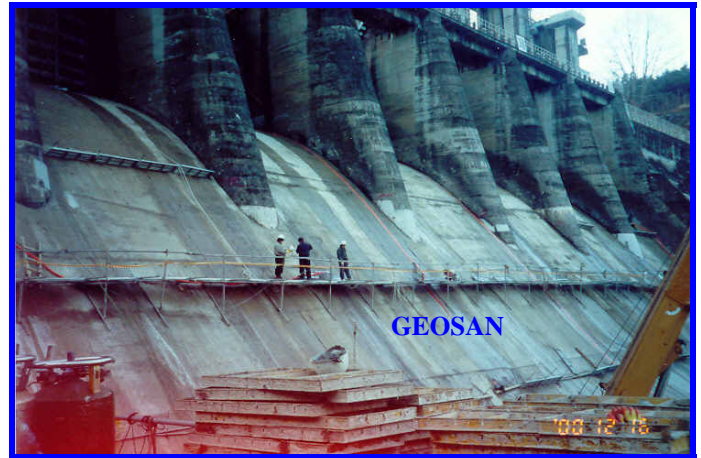
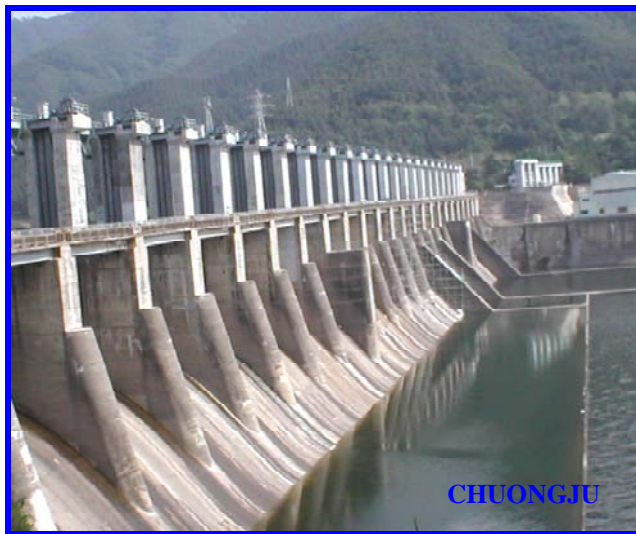
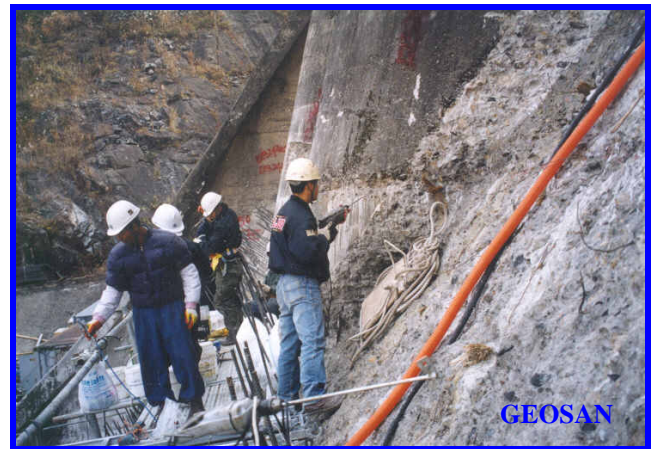
Objective: repair deteriorated concrete of the intake areas, spillways and piers of several dams – Geosan, Chuongju and others. The freeze thaw damage of poorly compacted areas were repaired using a high performance fibre cement composite – **Gem-Crete HDO**. The material selected was extensively tested for this application by the U.S. Army Corps of Engineers. It also obtained a special “high tech” certificate in Korea. The thickness of the repairs varied from 1 cm to 10 cm in depth. The material was hand applied after extensive and thorough surface preparation.
